## **Property Inspection Report**

Date Inspected	18/10/2023
Property Address	10 Firs Lane
Who will be managing the property	Agent
Does the LL/Agent have a licence?	No

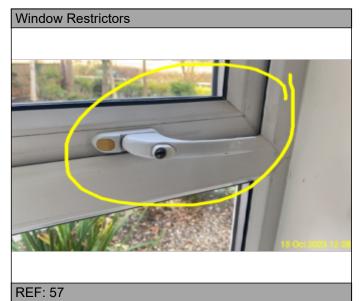
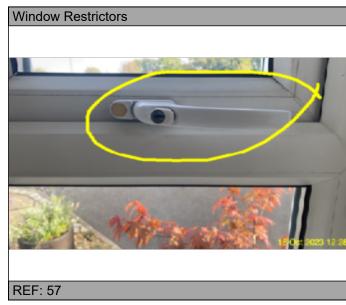
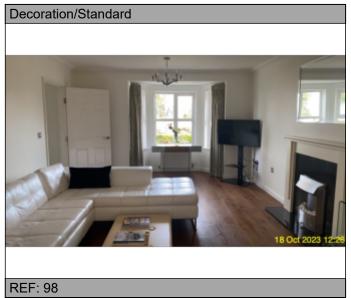
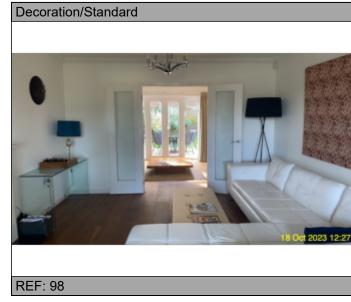
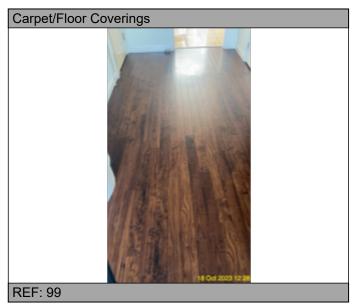
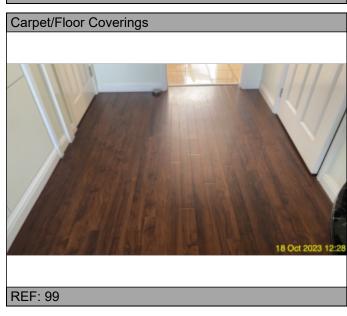
Reception room 1	Response	Comments
Window Restrictors	No	Instruct the maintenance team to supply and fit window locks
Decoration/Standard	Excellent	The room has been repainted before the tenants moved in
Carpet/Floor Coverings	Good	Parque floors throughout the ground floor

Room	Item	Comment
Reception room 1	Window Restrictors	None fitted throughout the property
Hallway	Window Restrictors	Contact the maintenance team to supply and fit window locks

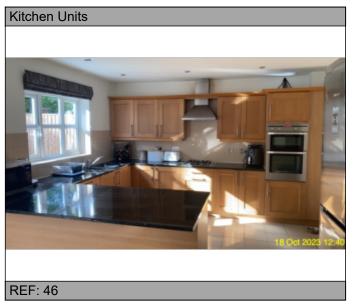
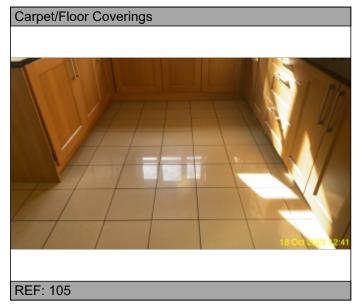
Response	Comments
Heat Alarm	N/A	
Fire Door with self-close (must shut unassisted to fully closed position)	N/A	
Kitchen Units (check doors and drawers open & close)	Good	Good condition no scratches or marks
Window Restrictors	N/A	
Decoration/Standard	Excellent	
Carpet/Floor Coverings	Excellent	
Open plan kitchen/living room	Yes

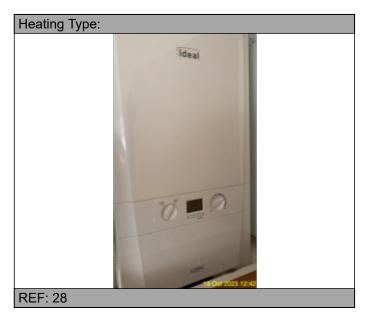
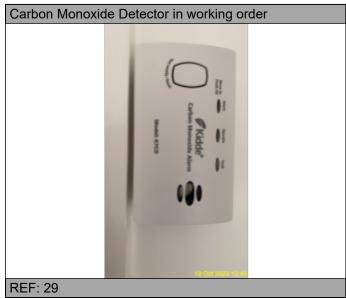
Response	Comments
Heating Type:	Gas	
Carbon Monoxide Detector in working order	Yes	
Please confirm there is a working Smoke alarm on every floor hallway/landing	Yes	
Hardwired/Battery Operated	Hardwired	
Is the property Double Glazed?	Yes	
Window Restrictors	No	
Decoration/Standard	Excellent	Repainted before the tenants moved in
Carpet/Floor Coverings	Good

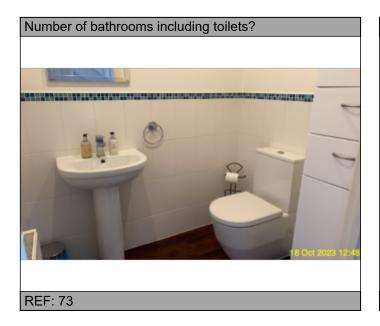
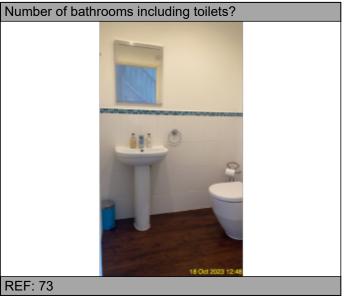
Bathroom 1	Response	Comments
Located on what floor	Ground floor	
Window Restrictors	N/A	
Decoration/Standard	Good	
Carpet/Floor Coverings	Good

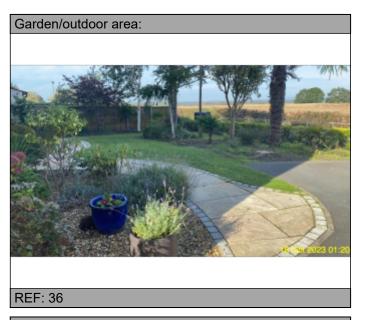
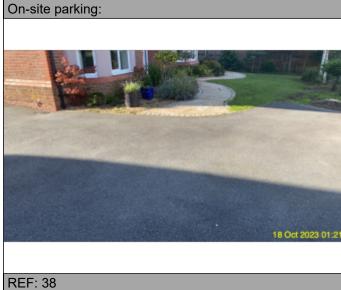
·		
	Response	Comments
Garden/outdoor area:	Garden	Well maintained and tidy
On-site parking:	Yes	
Front door has a double glazed multi point locking system or a rim cylinder lock with a secondary 5 lever mortice lock	Yes	
The roof must be fully watertight, missing, or loose tiles must be replaced. Flashing and flat roofs must be free from leakage. Roof must be stable e.g. if old slate tiles are replaced with modern heavier tiles the roof should be checked for bowing. All new type replacement roofs must have Building Regulations approval. Gutters must be free from debris.	Yes	
Is the roof intact and seem in good condition?	Yes	Visually inspected from the ground. No visible damage
Are the downpipes all present, and in good condition?	Yes	
Are the property boundaries secure with adequate fencing, walls, brickwork etc which does not allow anyone access externally	Yes

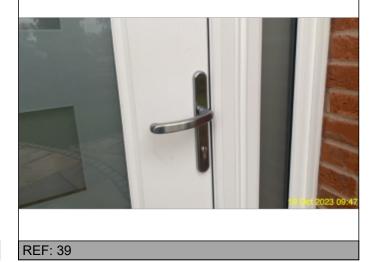
Front door has a double glazed multi point locking system or a rim cylinder lock with a secondary 5 lever mortice lock
